RE: USACE Armor Cap Reassessment of Western Berm
Administrative Order on Consent for Time Critical Removal Action
CERCLA Docket No. 06-12-10
San Jacinto River Waste Pits Superfund Site near Pasadena, Harris County, Texas

Review of Design, Construction and Repair of TCRA Armoring for West Berm of San Jacinto Waste Pits

FINAL REPORT--October 2013

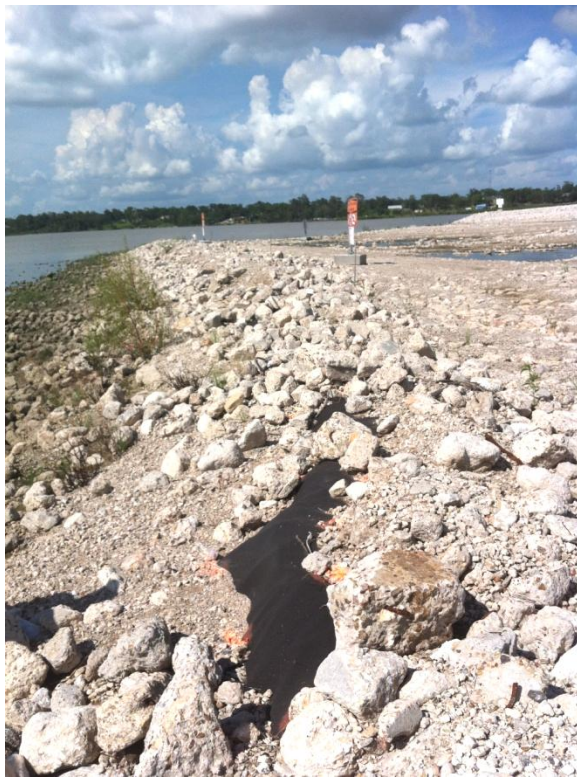
Figure 1. West berm.

This review of the design and construction of TCRA armoring for west berm of San Jacinto Waste Pits, TX is being conducted to address the performance of the armoring during a recent flood/storm event estimated to be a 10-year return event. Following the event, considerable movement or loss of armor material was discovered as evident in Figures 1, 2, 3 and 4.

Armor caps can be designed in three manners: 1) traditional with a base layer, filter layer and armor layer, 2) a graded armor layer (blended filter-sized stones and armor size stones) over the base layer, and 3) a base layer, geotextiles filter and armor layer. The first option is the common method for shallow marine construction; the second option is becoming a common option for deep water environments with shallow slopes; and the third option is commonly applied on shorelines with moderate to steep slopes. At San Jacinto the armor cap was designed with options 2 and 3 or a combination of options 2 and 3. Cap Configuration A consisted of geotextile placed on the base layer for constructability and then capped with blended armor and filter stones. The filter material also provided a bedding to protect the geotextiles from puncture by armor stone during construction. Cap Configurations B, C, D and E in the Final Removal Action Work Plan, Appendix A: TCRA Technical Specifications (September 2010) do not call for the use of armor stone blended with filter stone. Nevertheless, Figures 1 through 4 show a large quantity of gravels and sand in the Cap B/C, resembling a blended filter.

The armor stone specification is not well specified. The TCRA Technical Specifications, Appendix A (Anchor QEA November 2010) and USA Submittal 10 (Anchor QEA Feb 2011) cite only that 100% of the stones passes 12 inches with no more than 50% passing 6 inches and no more than 4% passing the #200 sieve. The armor stone should have had a specification of no more than 10% passing 2 inches to improve the uniformity and stability. The pictures in Figures 1 through 4 show an excessive quantity of gravel and sand size particles.

4. Repair should ensure that the final surface throughout the repair area and adjacent areas has a slope of 1V:3H or flatter.
